Regarding: Essroc San Juan Cement  
Compliance Evaluation Inspection, June 7, 2012 and Consent Decree (3:09-cv-01578)  
Individual Permit No. PR0001163 and MSGP 2008 Tracking No. PRR05BJ45  
Site visit: June 7, 2012  
Inspector: Murray Lantner, PE Environmental Engineer USEPA Region 2

The present letter responds to and clarifies the comments you raised as a result of your inspection performed of the stormwater conveyance systems at the Essroc site on June 7, 2012. Due to more than twelve (12) months of continuous compliance with applicable requirements, this letter is also intended to demonstrate our interest in terminating the Consent Order based on ESSROC's satisfactorily compliance with the requirements for termination under the Consent Decree.

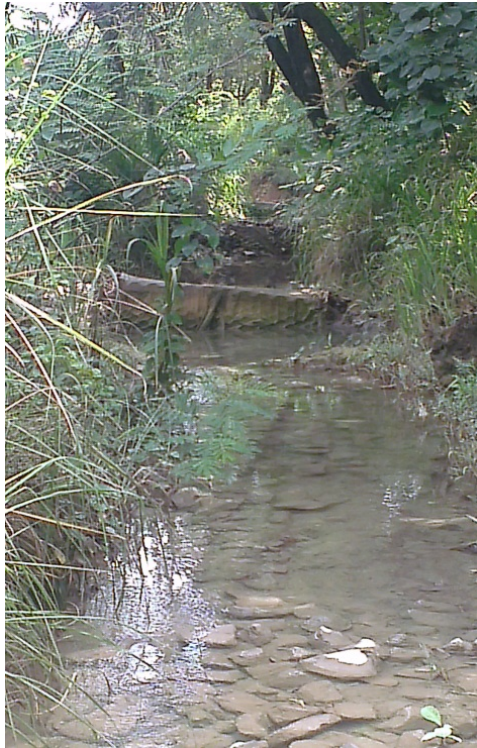
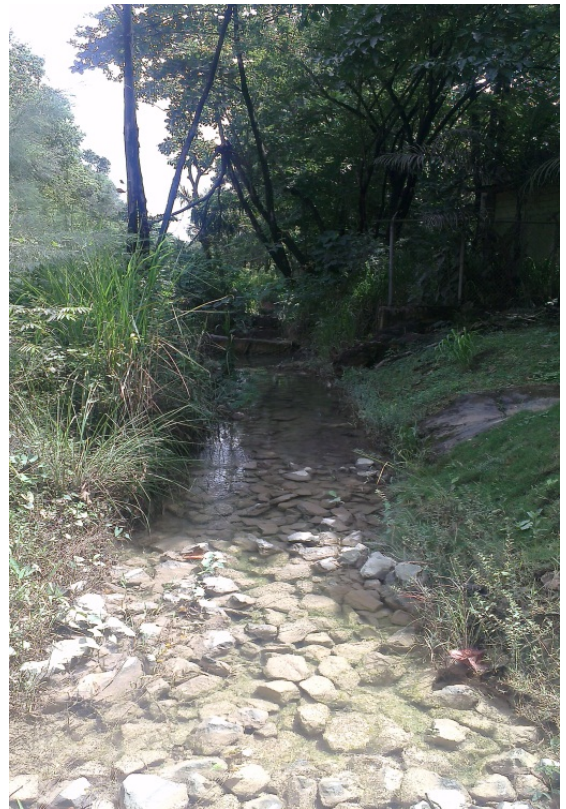
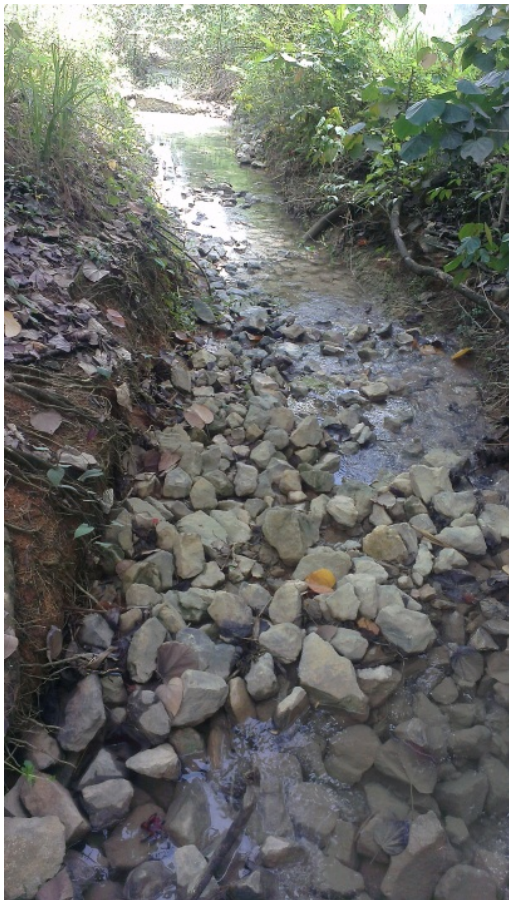
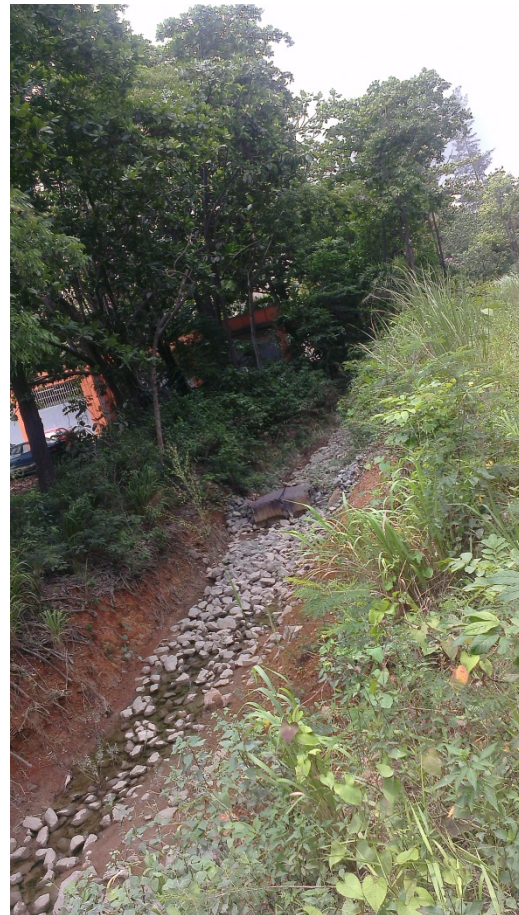
The following photos show how efficient the system is working, with rocks installed in bottom of channel, and the Gabions keyed at the channels walls:

Essroc refurbished the gabion system in December 2012 during which time the bottom of the channel was filled with rocks and new gabions were installed. This was performed to ensure that water does not flow around the gabions. Thus, Essroc has been complying with the EPA requirements and has upgraded the system to further ascertain its proper performance. Report and design of the Stormwater Consolidation Proposal and conveyance system upgrade was included in Quarterly Report send on January 28<sup>th</sup> 2013.

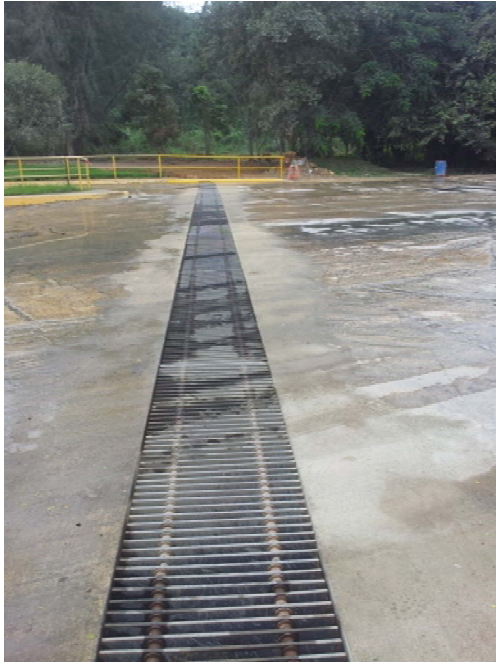
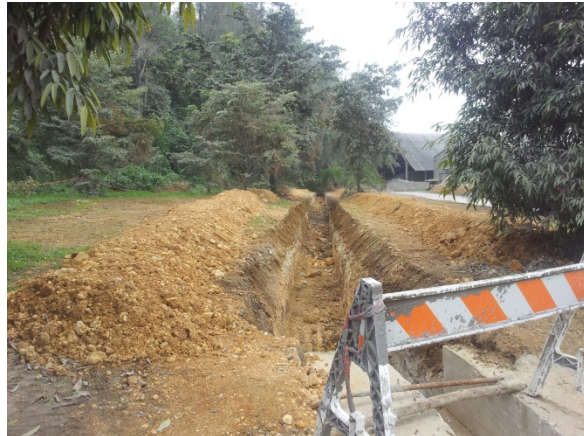
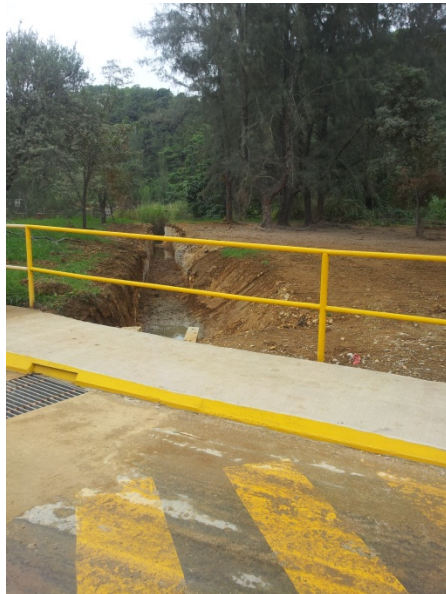
The following photos show the Storwater consolidation and re-direction system project performed in December 2012. A summary of the project's report and design was included in the Quaterly Report send on January 2013.

The cleaning of the channel was implemented during the consolidation and re-routing construction project performed in December 2012.

The pond forebays were included in the system.

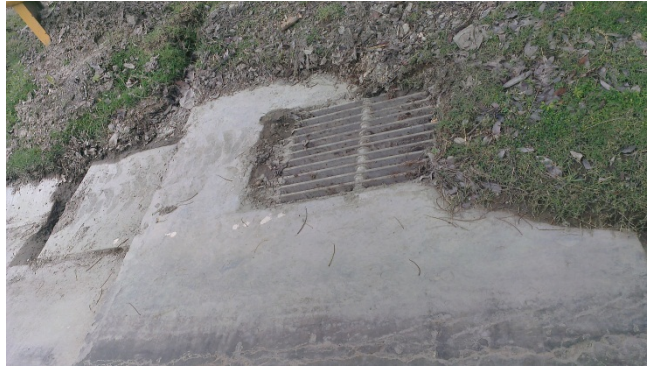
- h. **There was a clogged storm inlet along the road that is tributary to Pond No. 2**  
Maintenance to this storm inlet was provided on June 2012 to remove all material that was clogging the inlet.

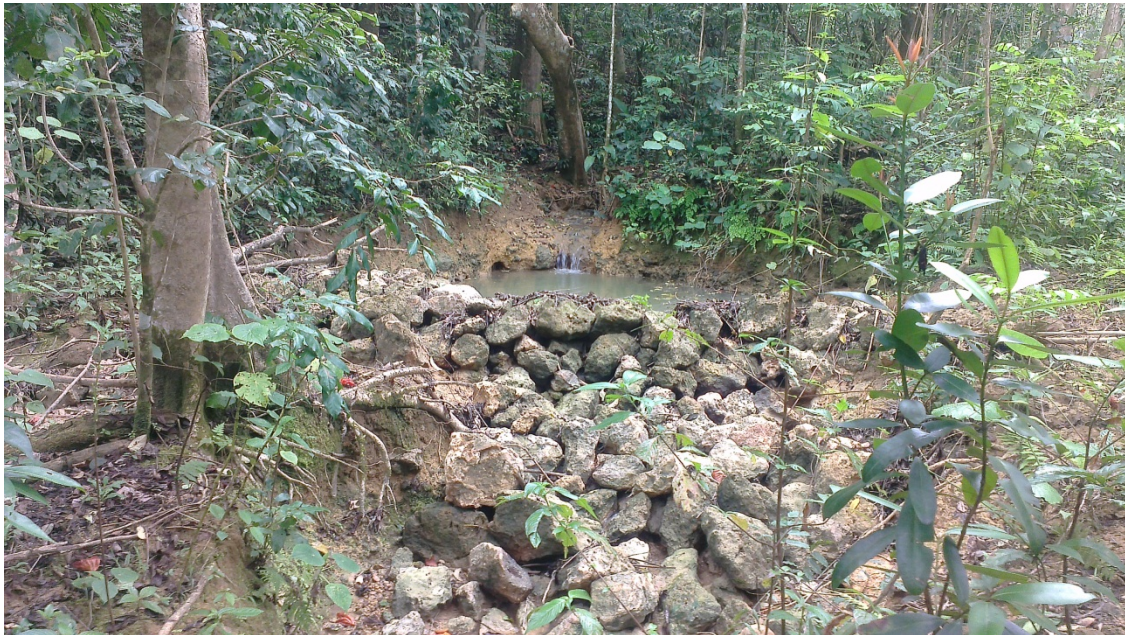
1. **... As shown in photographs... there was an eroded channel flowing towards and around the rock berm located between Quarry Areas 5 and 6. The area upstream of the rock berm should be stabilized the rock berm maintained to eliminate flow paths around the rock berm.**

This area was corrected.

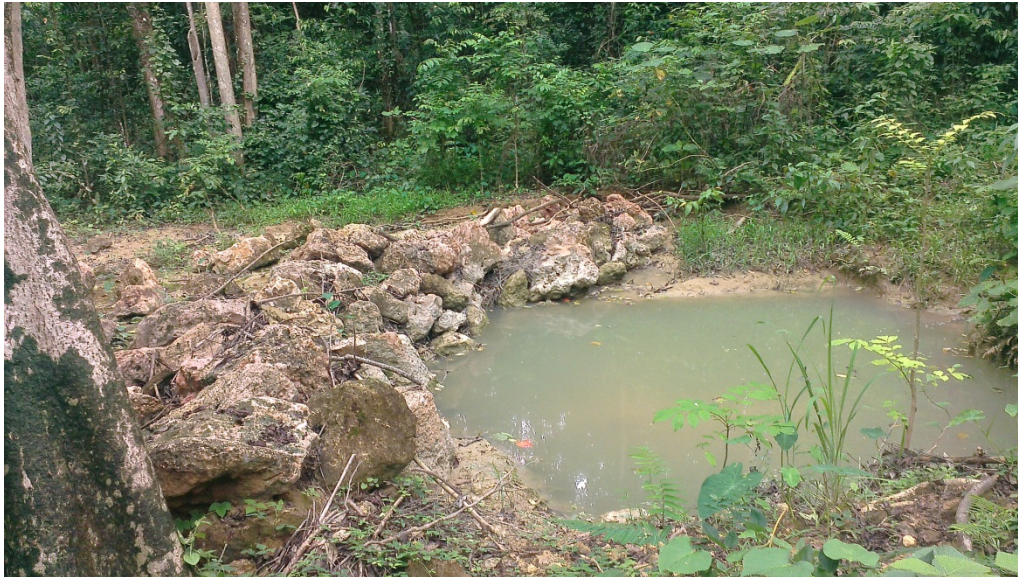
3. The final pond to discharge at SW Outfall No. 2 requires maintenance. Ms. Rivera, of Essroc, explained that Essroc would build up the outflow from this pond with rocks similar to other upstream ponds in the SW Outfall No. 2 flow channel.

Maintenance was performed during June 2012.
